Procedia Manufacturing

43rd Proceedings of the North American Manufacturing Research
Institution of SME <http://www.sme.org/namrc>

Mechanism of Surface Evolution in Vibratory Media Finishing

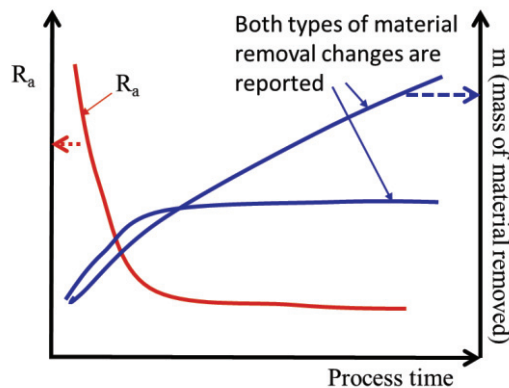
Figure 1. Surface roughness and mass removal changes in vibratory media finishing with process time

The nature of surface changes and how the surface evolves with time in the vibratory media finishing process is not entirely known. The component surface roughness finished by a vibratory media finishing process is known to saturate with time (Hashimoto & Debra, 1996)(Fig. 1). That is, after a certain process time, no further improvement in surface finish is possible. Detecting when this saturation occurs is important to determine process times. The mass change in the component being finished is however subject to some controversy; while some report continuous increase in changes (Hashimoto & Debra, 1996) others report (Baghbanan, et al., 2003) saturation in this parameter also. It is however reported that a rougher surface yields more material removal than a smoother surface. The cause of such saturation and its link to the nature of the media particles and process conditions are yet to be ascertained (Prakasam, 2014).

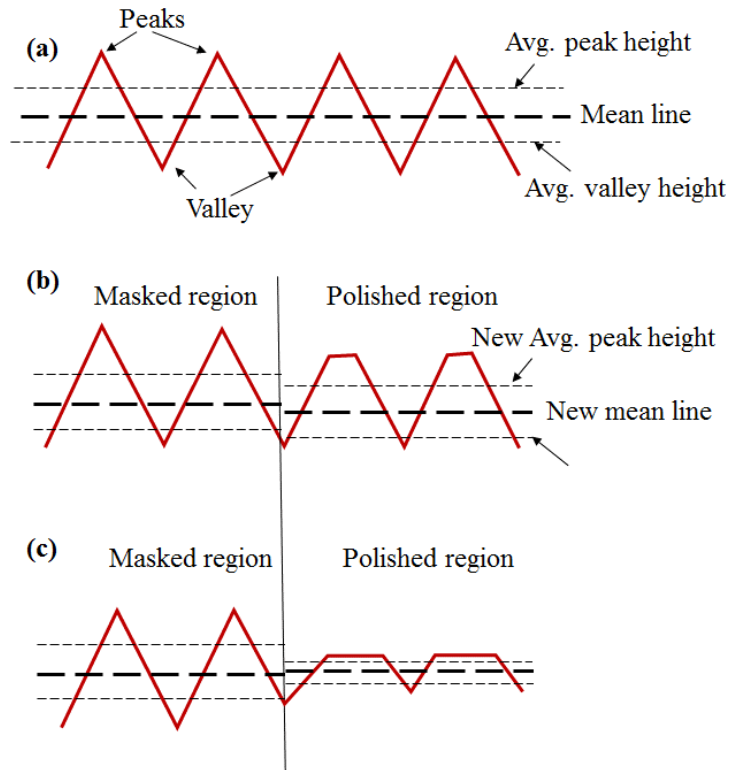
Figure 2. (a) Initial starting surface profile (b) Surface profile if pure material removal is occurring (c) Surface profile if some material removal and ploughing is occurring

The idea of using surface profile changes to explain whether material removal or indentation type ploughing is occurring can be explained as follows. Consider that we have a structure surface profile with well discernable peaks and valleys to start with as shown in Fig. 2a. The mean line is measured and can be used as datum. The peak height and the valley depth from this reference mean line can be recorded. Under pure material removal conditions only the peaks will get eroded and resulting profile will be as in Fig. 2b. The new mean line will shift downwards but the height of the peaks and depth of valley from the original mean line (not the new mean line) can indicate if pure material removal occurs – peak height will change, but not the valley depth from the original mean line. If the valley depth also changes as shown in Fig. 3b, then some amount of indentation type ploughing and plastic displacement has occurred; in this case the cause of peak height changes can be because of material removal or plastic indentation.

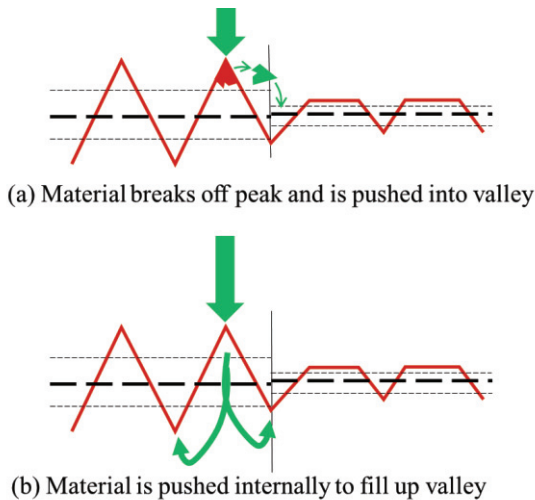
Figure 3. Two ways in which valley height can decrease (a) debris from removed material gets pushed into the valley (b) plastic deformation of the peak gets pushed internally to rise the valleys

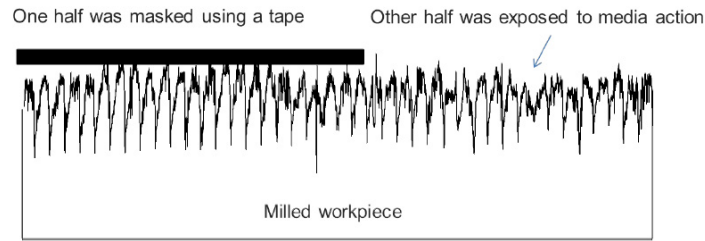
Figure 4. Masking one region of the surface being finished to retain the original mean line datum. Surface profile trace measurement is taken together in the masked (after removing the tape) and unmasked finished region together in one setup.

To achieve the first condition, the surfaces of the component were machined using a single-fly cutter in a CNC milling machine to generate uniform structured surfaces of about 10µm height and 150µm spacing. The fly-cutter used was a standard carbide cutting tool with ground edges. Hence the tool edge radius is expected to be around 7-15 micrometers. The material selected for analysis a titanium alloy. To attain the second condition one region of the component surface is masked as shown in Fig 4.

The entire component surface together with the masked and unmasked regions are subjected to vibratory media finishing. At certain process time intervals, the component surface is measured by taking a surface profile trace measurement in the masked (after removing the tape) and unmasked finished region together in one setup. This way the original mean line datum is retained for comparison. The steps involved are thus as follows.

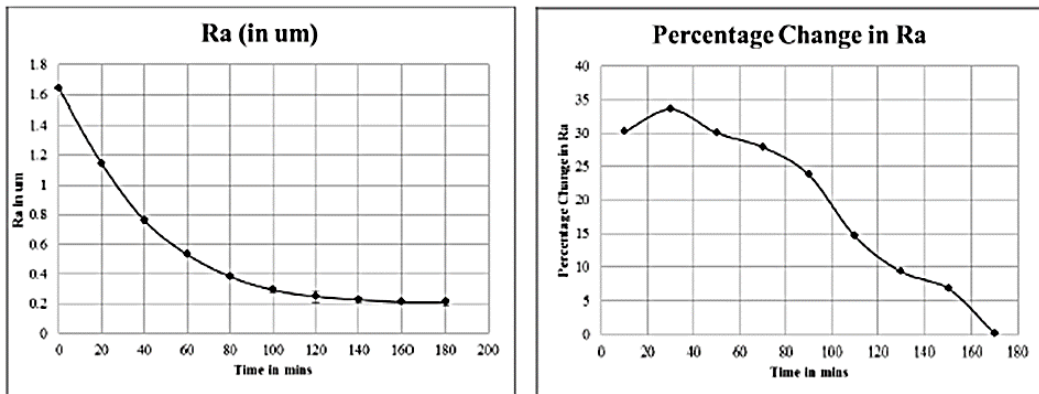
Figure 5. (a) Surface roughness parameter R_a evolution with process time (b) Percentage changes in R_a

The evolution of surface as quantified using the surface roughness parameter R_a is shown in Fig. 5. Typical saturation of the surface roughness is seen. Changes in R_a at the process intervals indicate a monotonic decrease in the change with time. More interesting trends are seen in the peak height changes and valley depth change with process time as shown in Fig. 6. Peak heights are seen to reduce monotonically and saturate while valley depths are seen to decrease and also reach saturation. Peak height saturation, valley depth saturation and surface roughness parameter R_a saturation all occur at a time close 100 minutes. It is clear from Fig. 6 that the process is not just one abrasion of peaks, since this is accompanied by valley depth decrease. Valley depth decrease could occur by debris pile-up but no evidence of this seen in the microscopy pictures to be discussed later. This means some of the peaks are getting pushed by plastic deformation into the valleys. If the percentage change in valley depth can be considered as an indication of plastic deformation, then one can plot the change as shown in Fig. 7. Evidence of plastic deformation can also be observed by examining microscopy pictures of the surface. This is presented next.

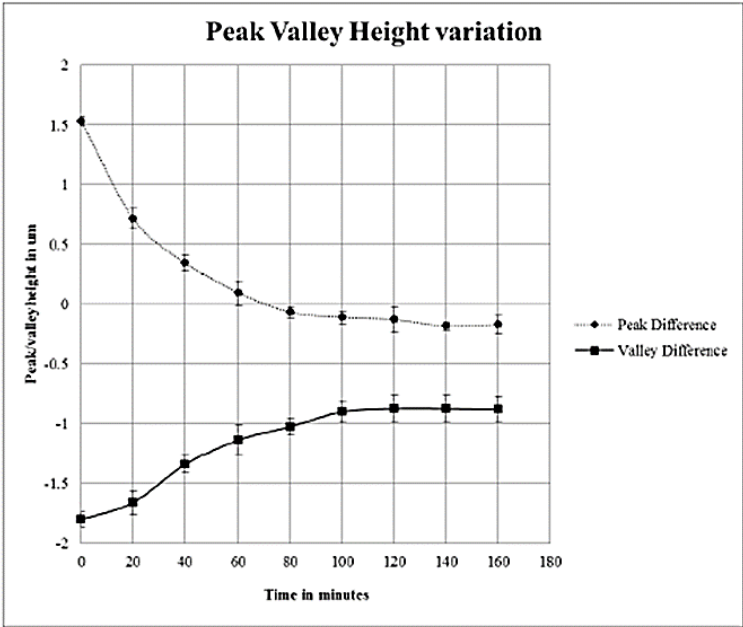
Figure 6. Peak height and valley depth changes with process time

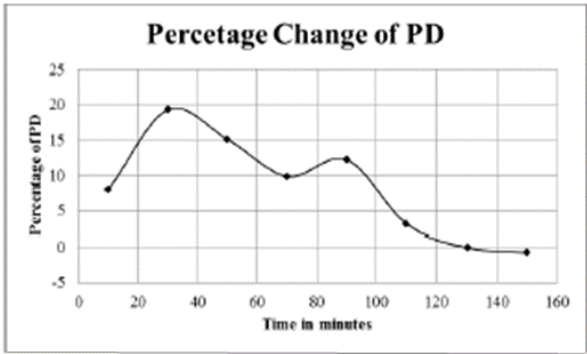
Figure 7. Interpretation of change in valley-depth as plastic deformation

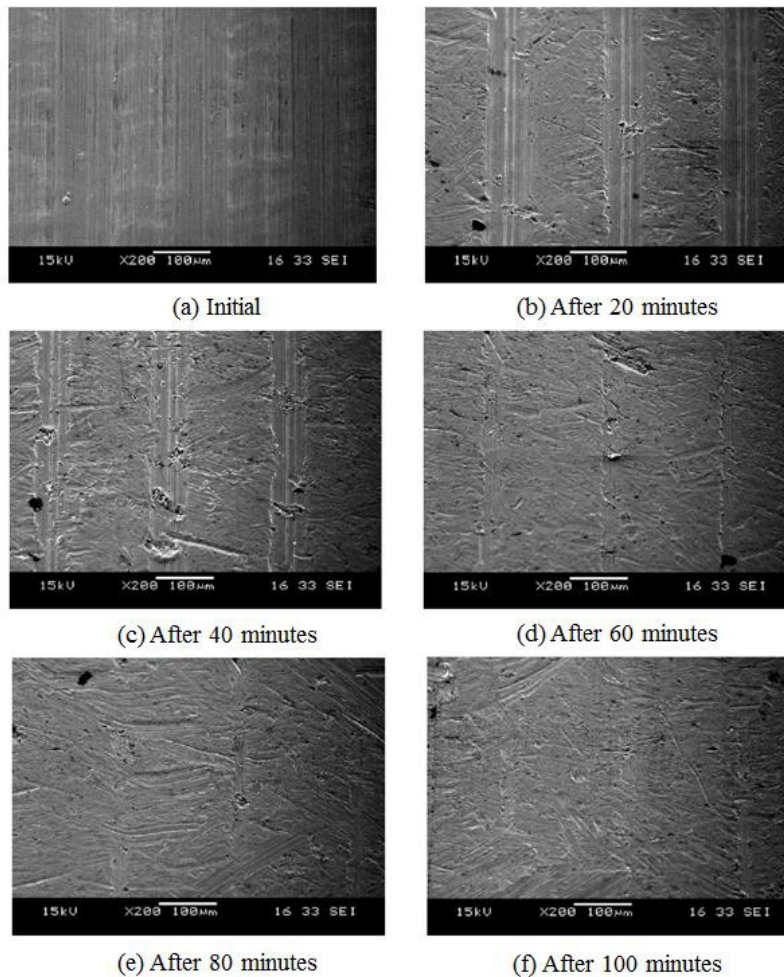
Figure 8. Scanning electron microscope examination of surface at various process time intervals

Scanning electron microscope images of the surface condition at different time intervals are shown in Fig 8. Fig. 8a shows the morphology of the initial surface before finishing and Fig. 8b after 20 minutes of finishing. It can be noted that the patches of surfaces have been modified by the finishing process, leaving behind traces of unchanged surfaces. These patches indicate the peak region of the structured surface. The peaks are modified initially, leaving the valley unaltered. This is also reflected in the peak and valley height change as shown in Fig. 8b at the 20 minutes time interval. Figure 8c shows the SEM pictures of surfaces formed after 40 minutes and Fig. 8d after 60 minutes. It can be noted that after 40 minutes, the valleys start getting affected by the media action. There are also presence of scratch marks on the surface, indicating the scratching behavior which causes more material removal than plastic deformation. This is also reflected in Fig. 8c, where the amount of plastic deformation is very less compared to material removal in the initial stages. After 60 minutes, it can be noted that the width of the valleys slowly reduces. If this change in surface morphology is due to material removal, the depth of the valleys will increase. But measurement of surface profile shows that the valley depth decreases, indicating that the peaks are being plastically deformed and pushed into the valleys. There are also no presence of wear debris particles present as seen in the SEM pictures. After 80 minutes (Fig. 8e), it can be noted that the valleys are almost deformed, and after 100

minutes (Fig. 8f) there is no clear separation between peaks and valleys. Also there are more number of plastically deformed edges indicating an increase in plastic deformation. We note here that the trends seen here are a strong function of material behavior (ductile vs brittle). A more brittle material such as hardened steel would perhaps show more peak erosion and less of plastic deformation. The material chosen here is an industrially used aerospace alloy and hence has practical relevance.
